ADDENDUM NO. 3  
TO THE CONTRACT DOCUMENTS  
for the construction of

C.C. WILLIAMS WASTEWATER TREATMENT PLANT  
DEWATERING AND OTHER IMPROVEMENTS PROJECT

Re: Pre-Demolition Asbestos and Lead-Based Paint Survey  
C.C. Williams Waste Water Treatment Plant (WWTP)  
1600 Yeend Street  
Mobile, AL  
SESI Project No.: M21-213

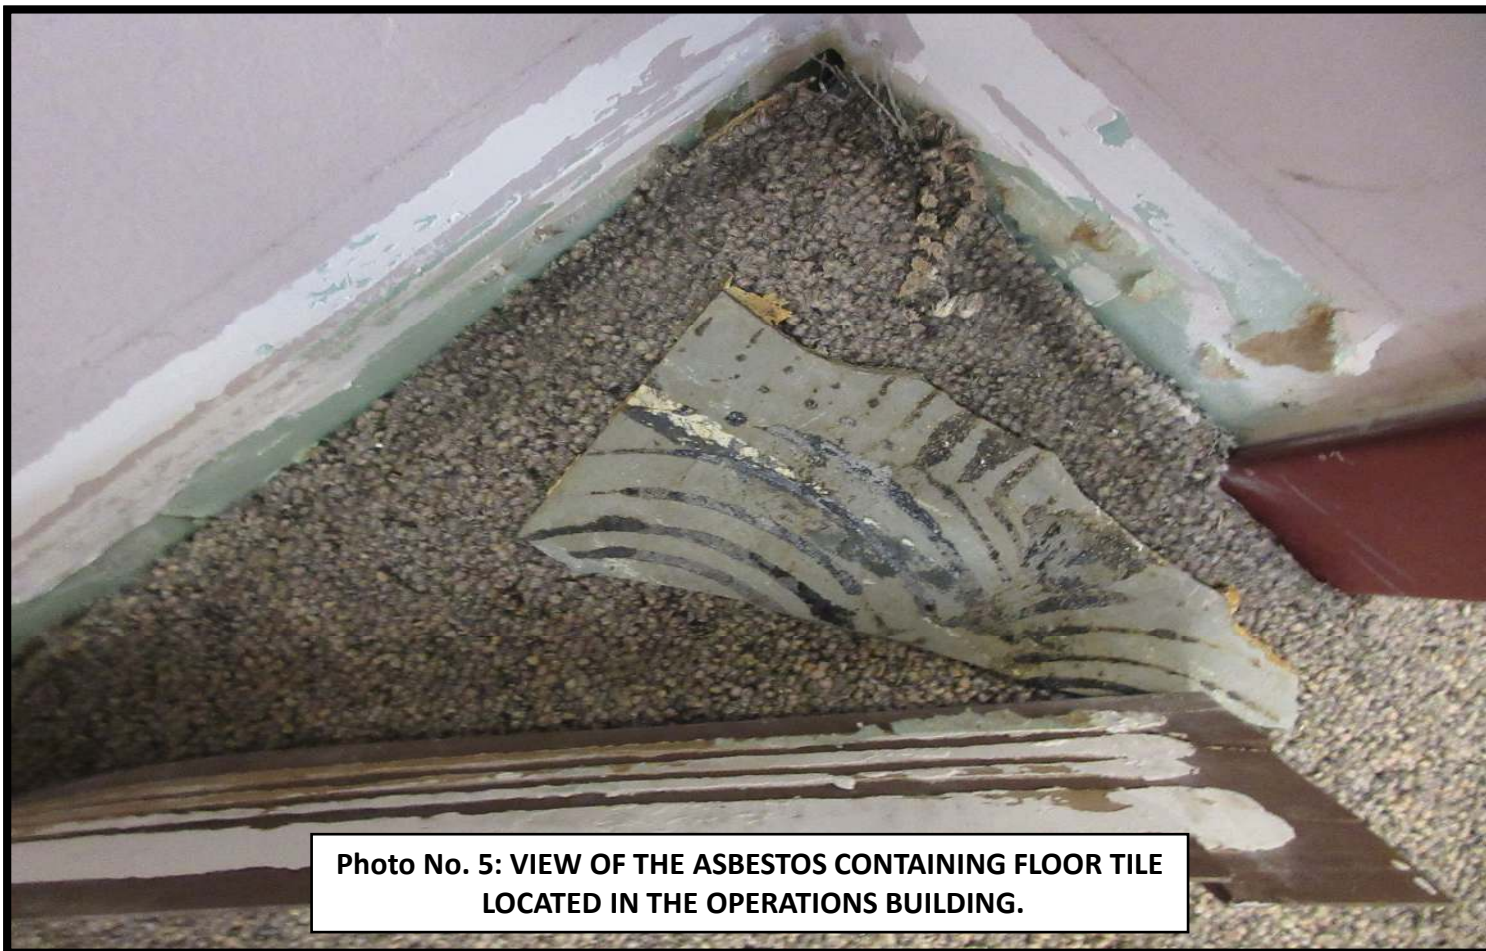
The Gray 9" x 9" Floor Tile contained 7% chrysotile asbestos. This material is considered a Category I non-friable ACM under the NESHAP regulation. There is approximately 1,100 square feet of the asbestos containing floor tile in the large conference room and the two northeast corner offices of the Operations Building.

**Photo No. 5: VIEW OF THE ASBESTOS CONTAINING FLOOR TILE  
LOCATED IN THE OPERATIONS BUILDING.**

The asbestos containing floor tile in the Operations Building is classified as a Category I non-friable asbestos containing material. This material may be left in place during demolition. However, if the material is left in place, the demolition debris must be disposed of in a C & D landfill that accepts non-friable asbestos containing materials and the building materials cannot be recycled. In addition, demolition with non-friable asbestos containing materials left in place is considered Class II work by OSHA (29CFR1926.1101) and requires worker and supervisor asbestos training. The non-friable materials that are left in place must be adequately wetted during all demolition activities to avoid "Visible Emissions" as described in NESHAPS regulations. An OSHA Competent Person must be on site during demolition to ensure proper engineering controls and work practices are utilized and to recognize suspect ACM. Therefore, we recommend that the asbestos containing floor tile be removed by an Alabama Accredited Abatement Contractor which will allow the demolition debris to be disposed of in a C & D landfill and recycling of building materials.

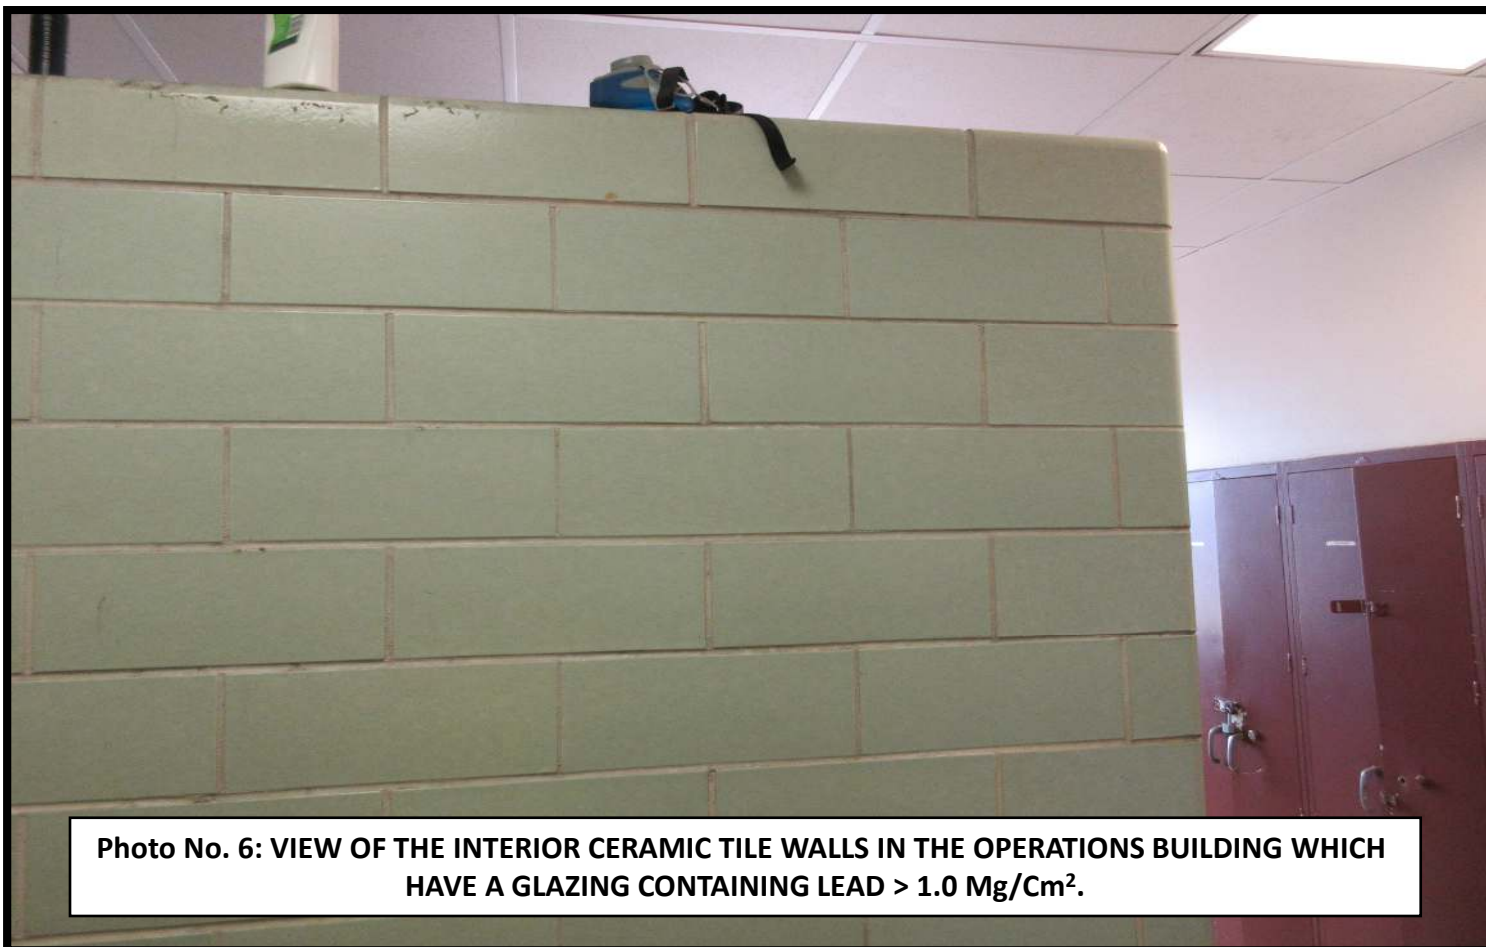
- Green Interior Ceramic Tile Walls in the Operations Building (Photograph No. 6)
- Green Interior Ceramic Tile Walls in the Chlorine Building (Photograph No. 7)

**Photo No. 6: VIEW OF THE INTERIOR CERAMIC TILE WALLS IN THE OPERATIONS BUILDING WHICH  
HAVE A GLAZING CONTAINING LEAD  $> 1.0 \text{ Mg/Cm}^2$ .**

A case by case assessment of each construction activity should be conducted to determine which components should be abated prior to disturbance. The assessment should include an evaluation of the type of work that will be conducted (i.e. drilling, sawing, demolition, repainting etc.), the concentration of lead detected in the painted surface, and the results of any available prior negative exposure air monitoring data. Contractors should follow these regulations when working with lead painted components and avoid activities (sanding, torch cutting, grinding, abrading) which could produce lead fume or respirable dust.

The EPA requires that solid waste containing lead be tested using the Toxicity Characteristic Leachate Procedure (TCLP) for lead to determine if the waste must be disposed of as hazardous waste. A composite sample of any paint-chips and building components known to contain lead should be analyzed using the lead TCLP before disposing of such waste. If the laboratory results for the TCLP analysis are greater than 5.0 milligrams per liter (or

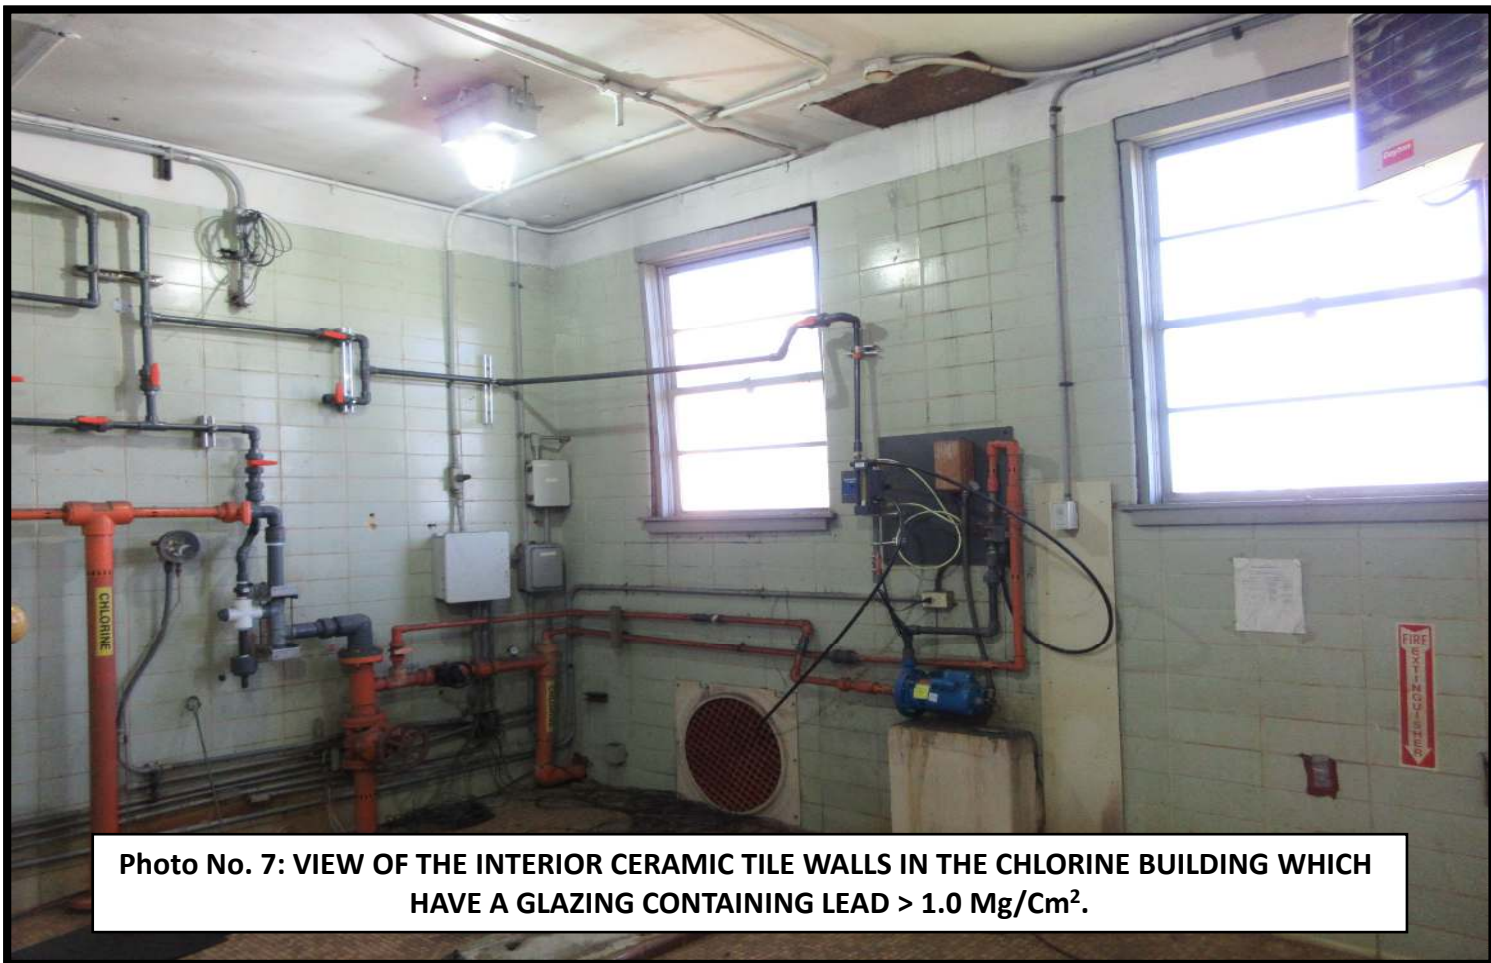
**Photo No. 7: VIEW OF THE INTERIOR CERAMIC TILE WALLS IN THE CHLORINE BUILDING WHICH HAVE A GLAZING CONTAINING LEAD > 1.0 Mg/Cm<sup>2</sup>.**

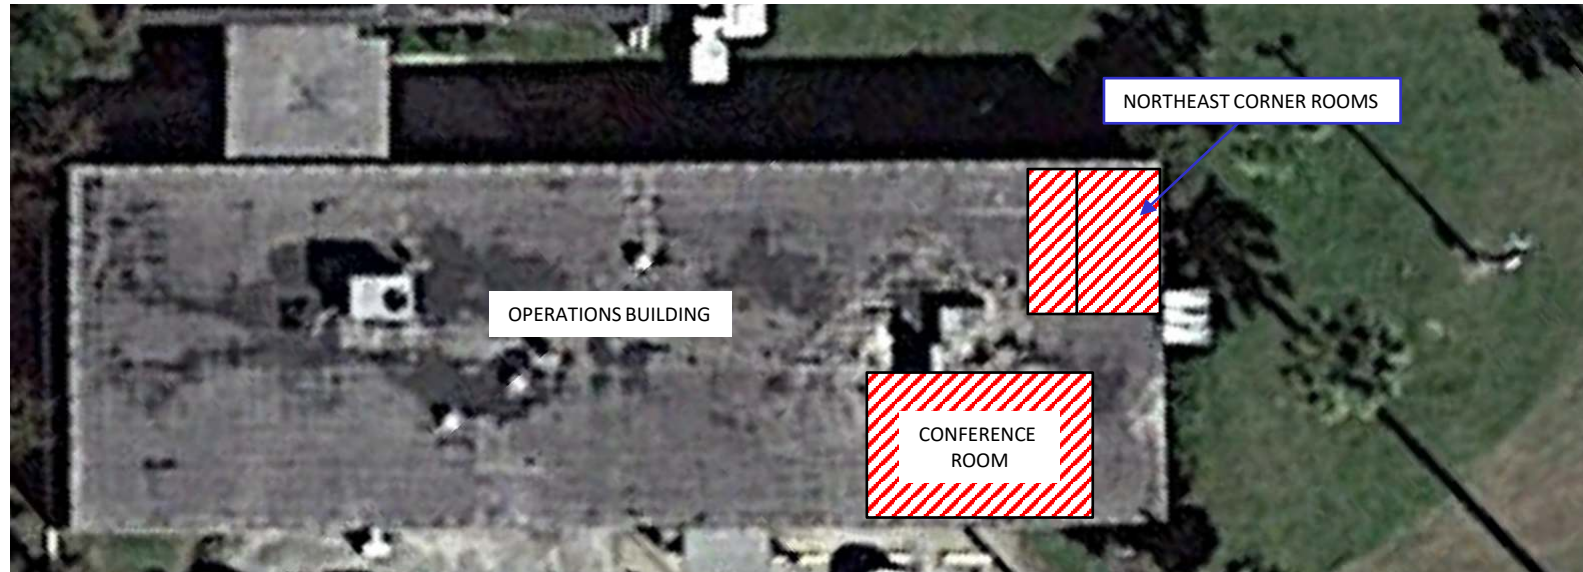
= Asbestos Containing Flooring
